**4.3.5.2 Unit Type AP50-69.3.Y APPR 50-69 Unrenovated**

**Base Name:** Holloman Air Force Base

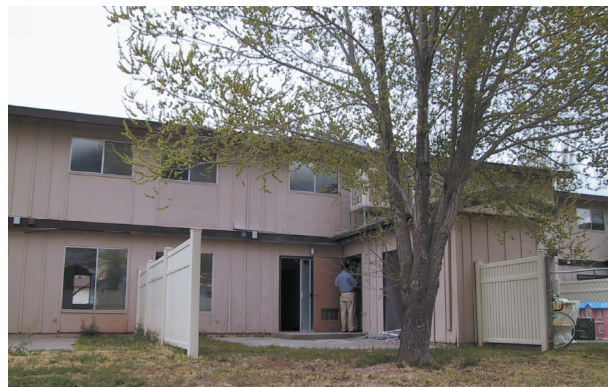
*Rear elevation*

- Windows - Screens: aluminum; deteriorated condition; screens are either bent, torn, or missing.
- Doors - Entry: wood; fair condition; multiple coats of paint.
- Doors - Sliding Glass: metal; deteriorated condition; dated door with no secondary locking device; single glazing.
- Doors - Storm/Screen: aluminum; poor condition; dated screen door.
- Doors - Hardware: brass; fair condition; entry door does not have dead bolt.

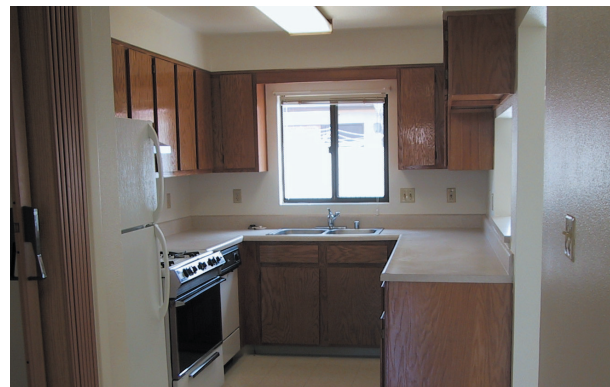
*Kitchen*

- Cabinets: wood; good condition.
- Counter Tops: laminated; good condition.
- Sink: stainless sink; double; good condition.
- Sink Fixtures: chrome; good condition.
- Refrigerator: standard; good condition.
- Range/Oven: gas; good condition.
- Vent Hood: exhaust fan; good condition.
- Dishwasher: standard; fair condition; worn heating element.
- Garbage Disposal: standard; fair condition; older model.
- Flooring: vinyl composite tile; good condition.
- Walls: gypsum wall board; good condition.
- Wall Finish: painted; good condition.
- Ceilings: gypsum wall board; good condition.
- Ceiling Finish: painted; good condition.
- Interior Hardware: none; not required.

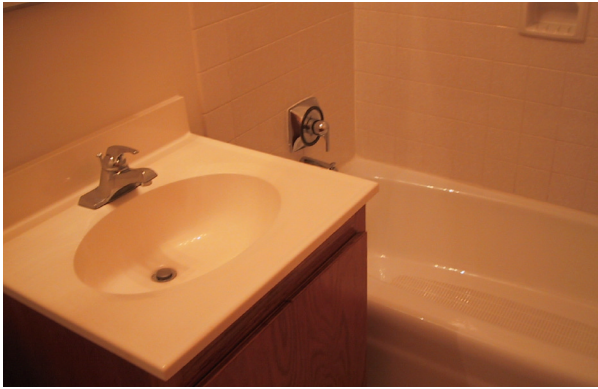
Bathroom 1

- Cabinets: wood; fair condition; worn finish.
- Counters: cultured marble; good condition.
- Sink: cultured marble; good condition.
- Fixture Hardware: metal; good condition.
- Toilet: porcelain; good condition.
- Tub/Shower: combination; good condition; ceramic tile surround.
- Flooring: vinyl composite tile; fair condition; loose at toilet.
- Walls: gypsum wall board; good condition.
- Wall Finish: painted; good condition.
- Ceilings: gypsum wall board; good condition.
- Ceiling Finish: painted; good condition.
- Ventilation: exhaust fan; fair condition; older unit.
- Interior Hardware: metal; good condition.

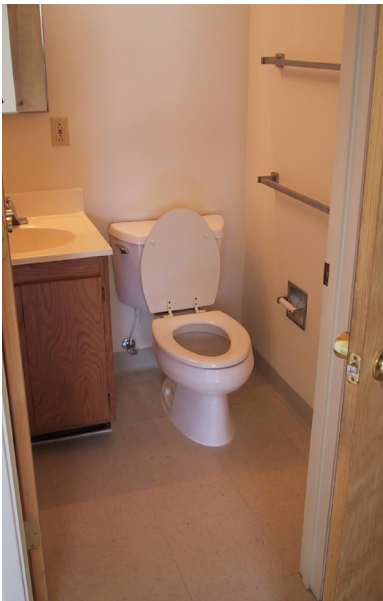
Bathroom 2

- Cabinets: wood; fair condition; worn finish.
- Counters: cultured marble; good condition.
- Sink: cultured marble; good condition.
- Fixture Hardware: metal; good condition.
- Toilet: porcelain; good condition.
- Tub/Shower: shower; good condition; ceramic tile surround and glass door.
- Flooring: vinyl composite tile; good condition.
- Walls: gypsum wall board; good condition.
- Wall Finish: painted; good condition.
- Ceilings: gypsum wall board; good condition.
- Ceiling Finish: painted; good condition.
- Ventilation: exhaust fan; good condition.
- Interior Hardware: metal; good condition.
